## Pantera Console Switch Repair

*By John Taphorn - January 1<sup>st</sup>, 2014*

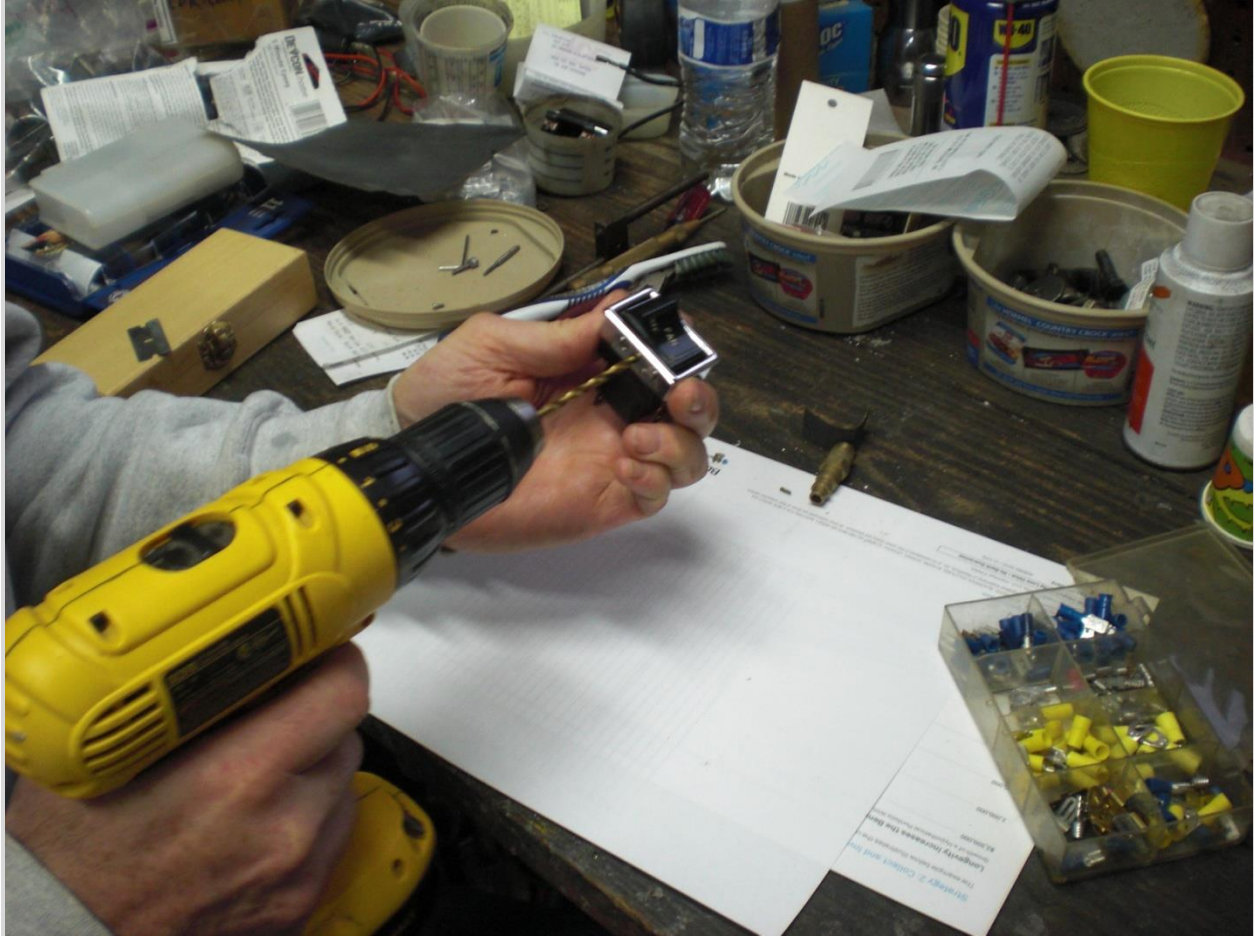
I have rebuilt over a dozen switches and there are two methods employed to attach the chrome bezel. One method has the bezel held in place by only the single visible horizontal rivet. The second method has the bezel held in place by an additional two vertical rivets. These vertical rivets will not be obvious until you remove the toggle button (hereafter referred to as the button). I suspect that the original switches used three rivets and depending on the remanufacturer, subsequent replacements only one.

Use a drill bit of larger diameter than the long horizontal rivet to remove one of the rivet's flanged sides. The rivet will then slide out and the button is now removable. Treat the rivet with respect as it will be used again when reassembling the switch. If you do not see two rivet flanges holding the bezel to the case after removing the button, carefully pry the bezel from the case with a screwdriver from the side. It should come off easily.

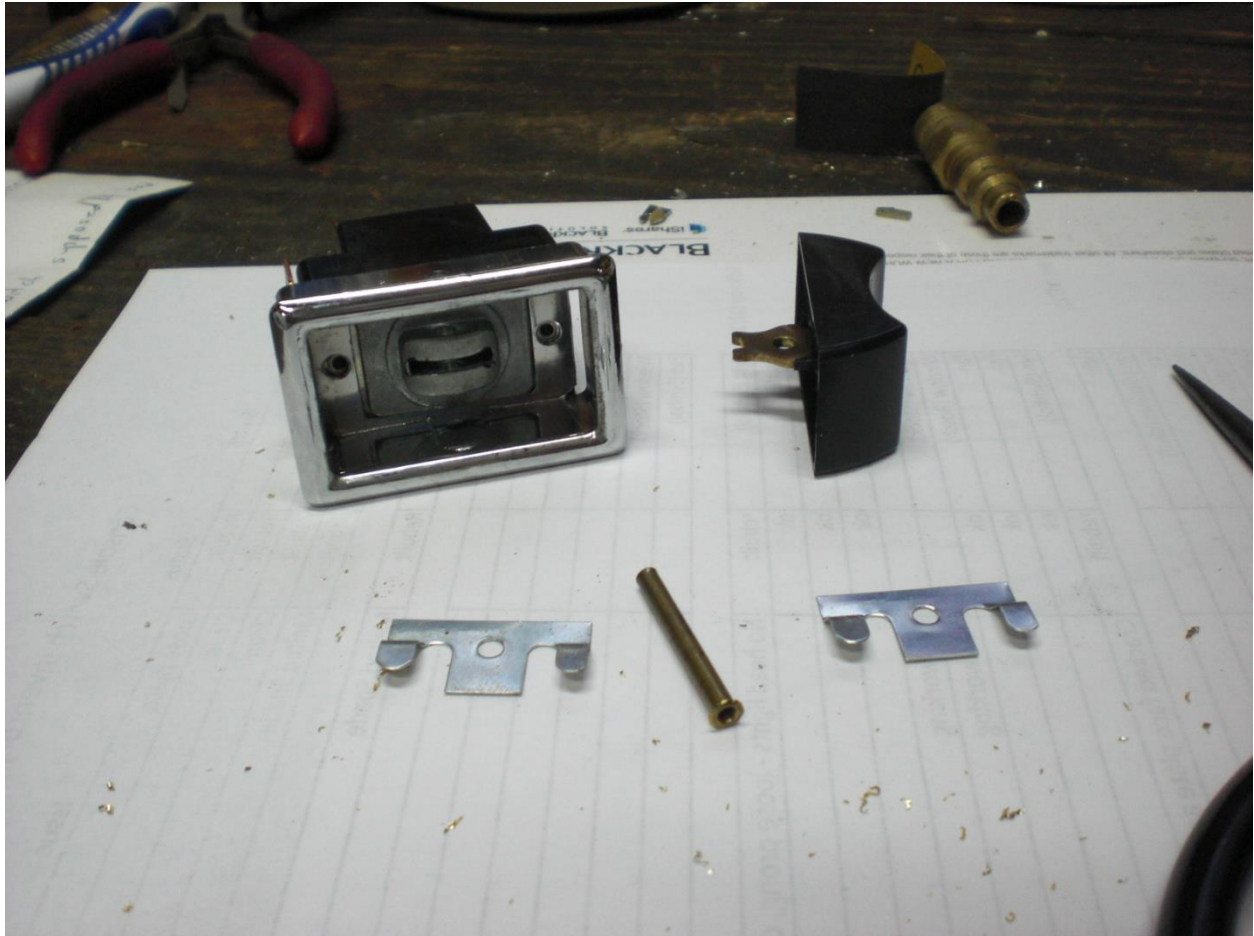
*This bezel is not held in place by the two vertical rivets and can be pried off. The holes are there and the rivets holding the base plate to the case are seen behind them.*

Otherwise, drill off the flanged heads of the two shorter vertical rivets from the bezel side. Now the bezel will separate from the rest of the switch. Caution, if you only intend to replace the bezel, be careful to hold the base plate, upon which the bezel sits, together with the case or a larger project is in store for you.

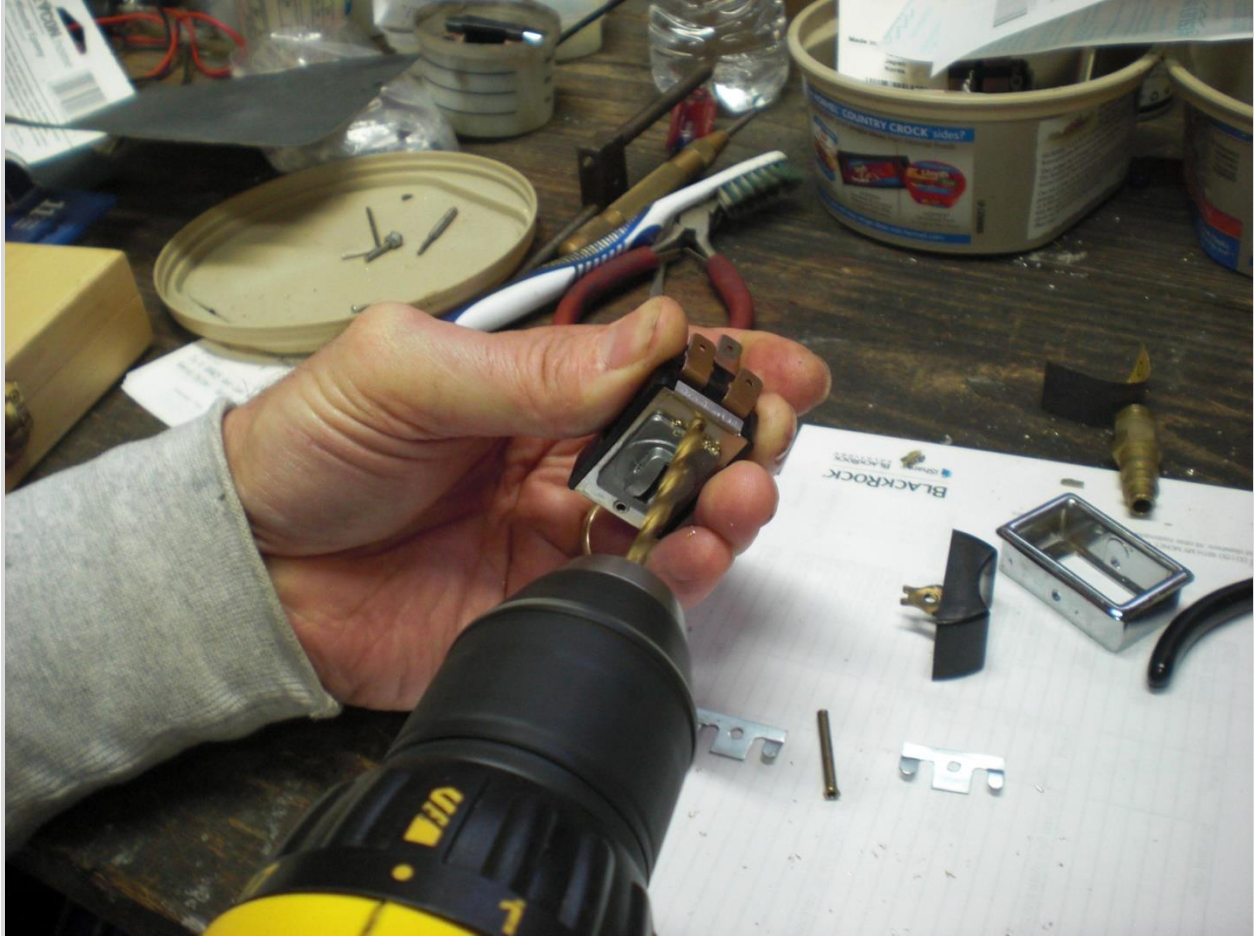
*On this switch the two vertical rivets did not hold the bezel, only the base plate to the case.*

Assuming you have removed the two vertical rivets, as you pull the base plate from the case, be mindful of the little pieces that may fall free. Now you are able to inspect the individual pieces for refurbishment or replacement.

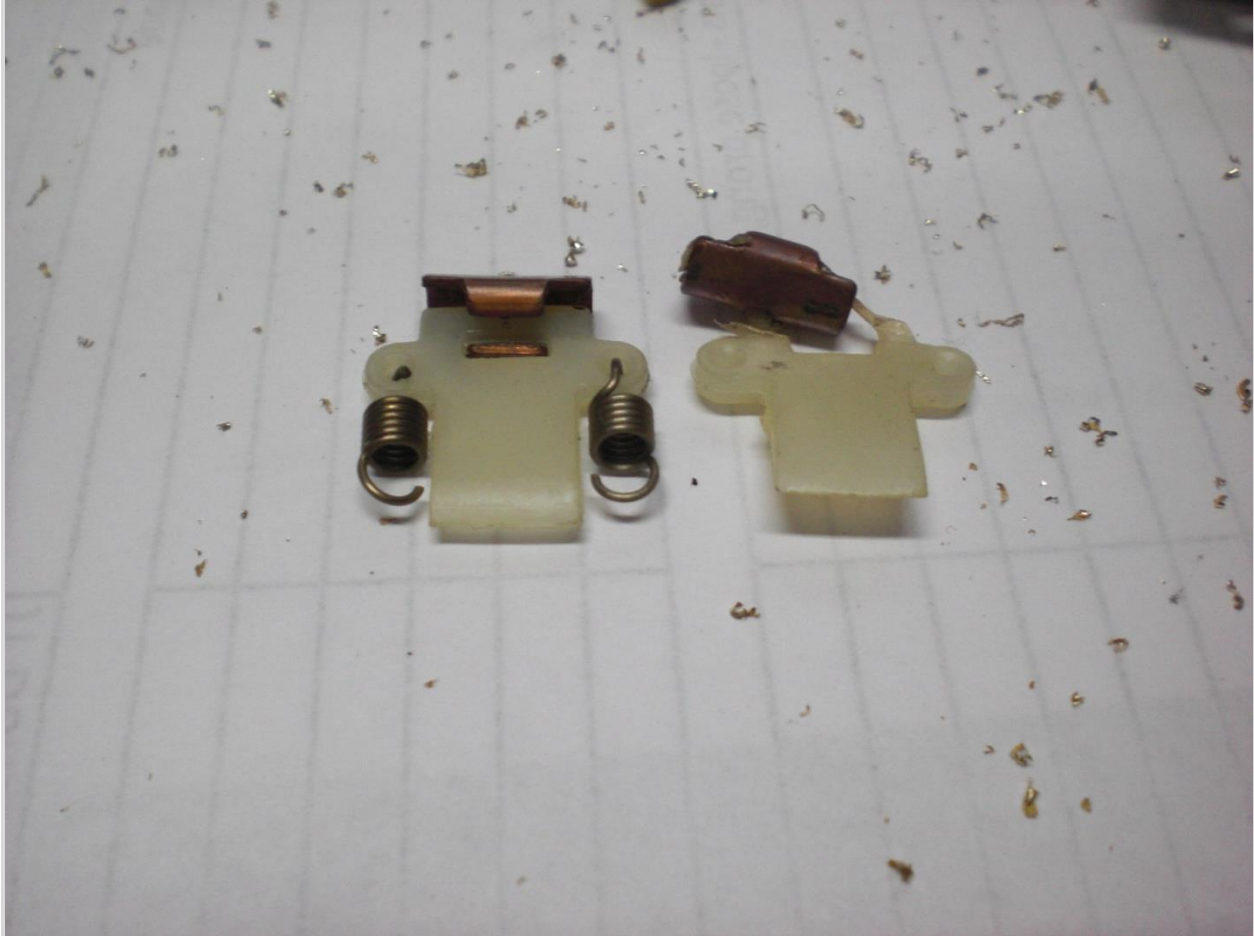
- 1) The condition of the nylon spades. A good spade is pictured on the left. On the right is a melted spade. When encountering a melted spade, a second switch in inventory is handy. I have yet to see a switch where both spades were bad. I do not know where to purchase replacement spades. For that matter, if you know the company remanufacturing these switches, please share.

*Note: The end of the spring that would attach to the base plate is open to the inside of the spade.*

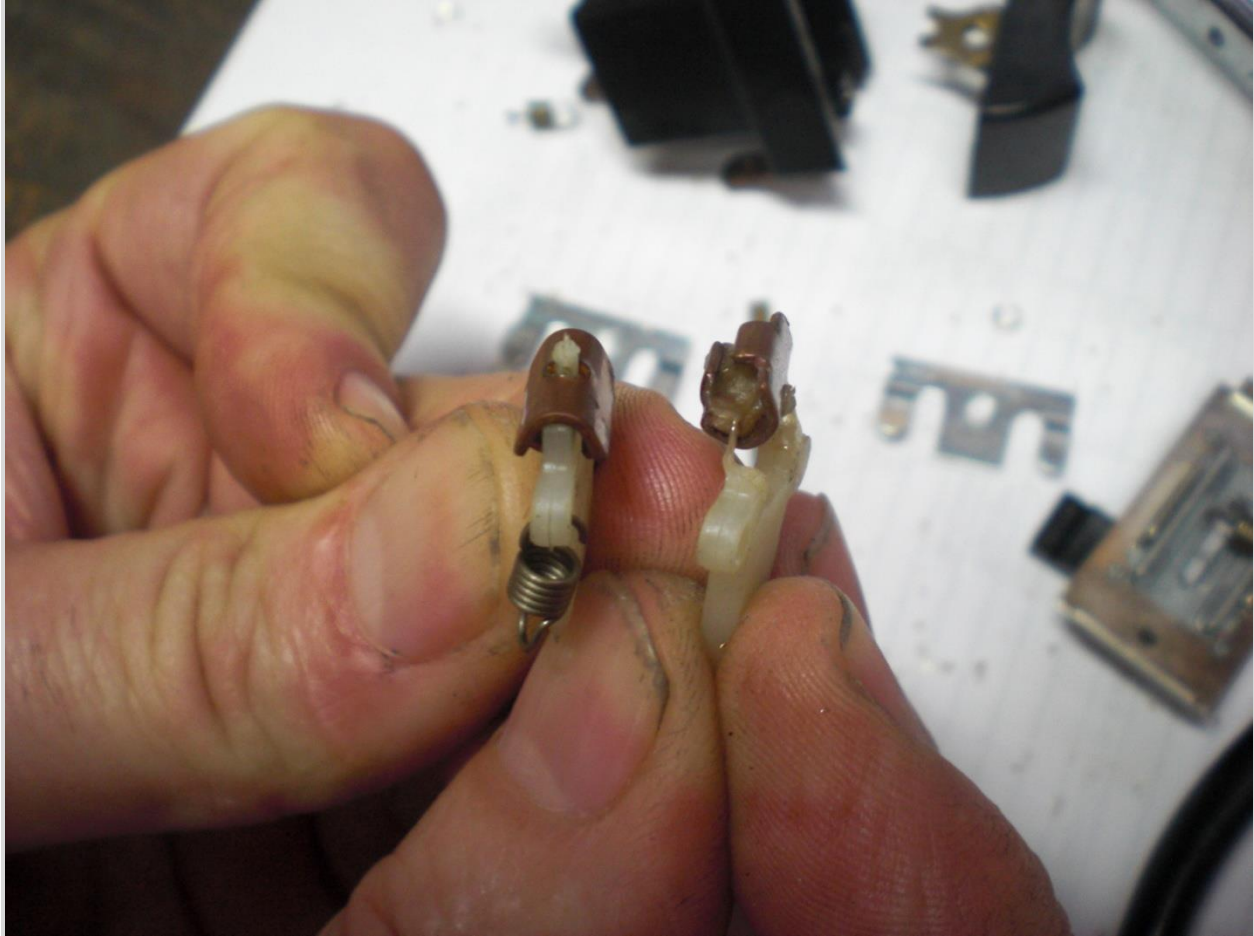
*I polish the spade's electrical contact with a wire wheel.*

- 4) Corrosion on the tabs and spades. I use a wire wheel on the spade's electrical contacts; but the tabs are tougher to clean due to their close proximity to one another in the case. I simply use a narrow wooden stick and 220 grit sand paper for the task. Sandblasting may be optimal.

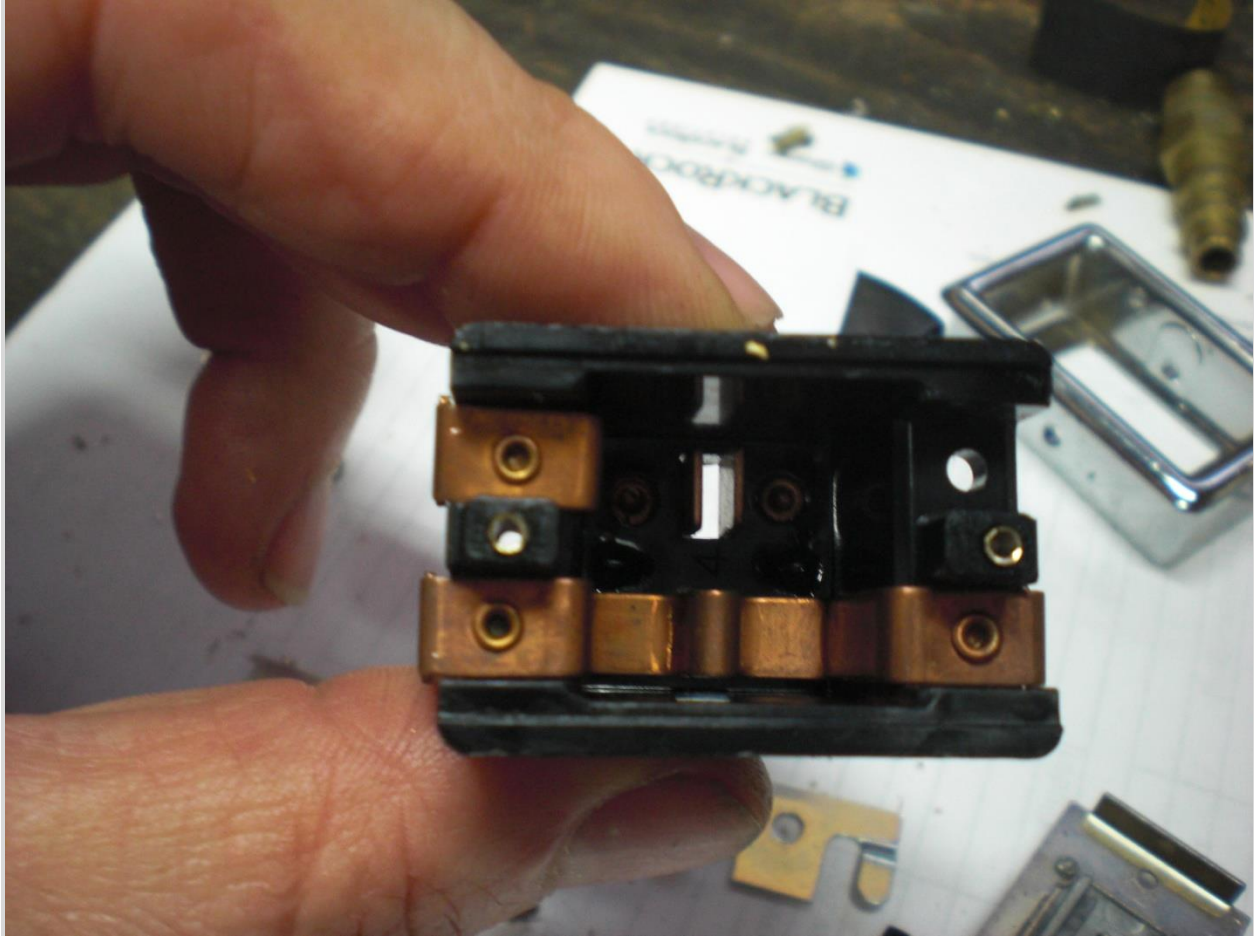
- 2) The rivets holding the copper tabs. The alignment of the copper tabs is critical. Rough handling when connecting or removing wire leads can loosen the rivets that hold the tabs. If the tabs are loose and able to shift, their internal alignment is compromised and electrical connection lost. They can easily be restaked with a punch while the case is separate. Occasionally, high heat warps the case causing tap misalignment. I have reused mildly warped cases after using needle nose pliers to realign the tabs.

*Picture of rivets holding the tabs*

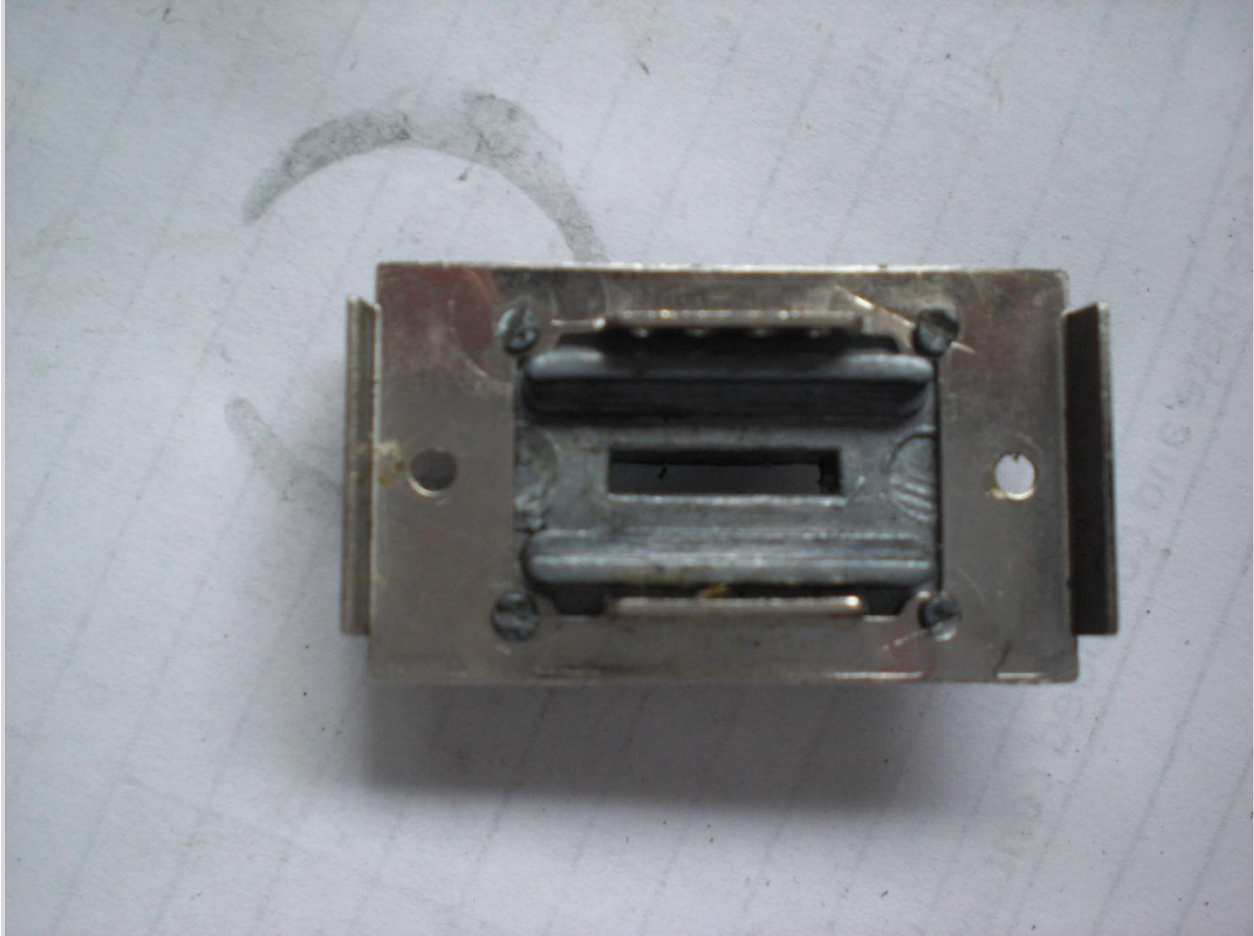
- 3) Check for looseness of the glide plate to the base plate. Guide plates may be resecured with a sharp chisel and light tap on the prong with a hammer.

*You can see marks on the bottom of the base plate where the guide plate's prongs were restaked.*

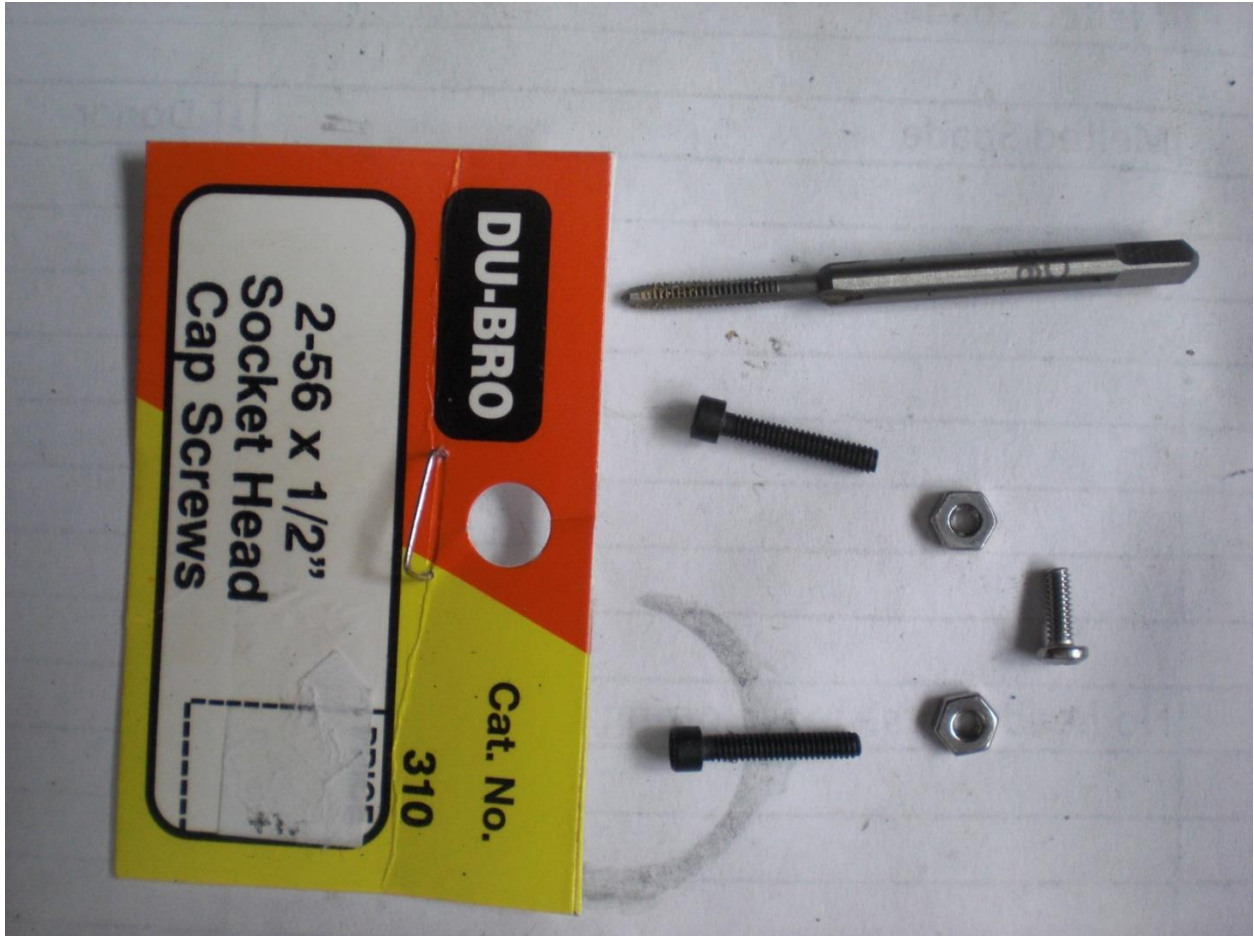
- A) Two 1/2" long #2-56 thread socket head cap screws with small diameter stainless nuts. The reason for stainless nuts is that they are manufactured smaller and clearance is an issue. The socket heads fit the case perfectly. I source the nuts from my local Ace Hardware and the bolts from a local RC/railroad hobby shop.
- B) Second, you will need a #2-56 tap. I get the tap from the hobby shop.
- C) A 1/4 inch long #2-56 threaded bolt with a flat seat and rounded head. Again, Ace Hardware. This screw is designed to minimize interference when reinserting the rebuilt switch into the console.

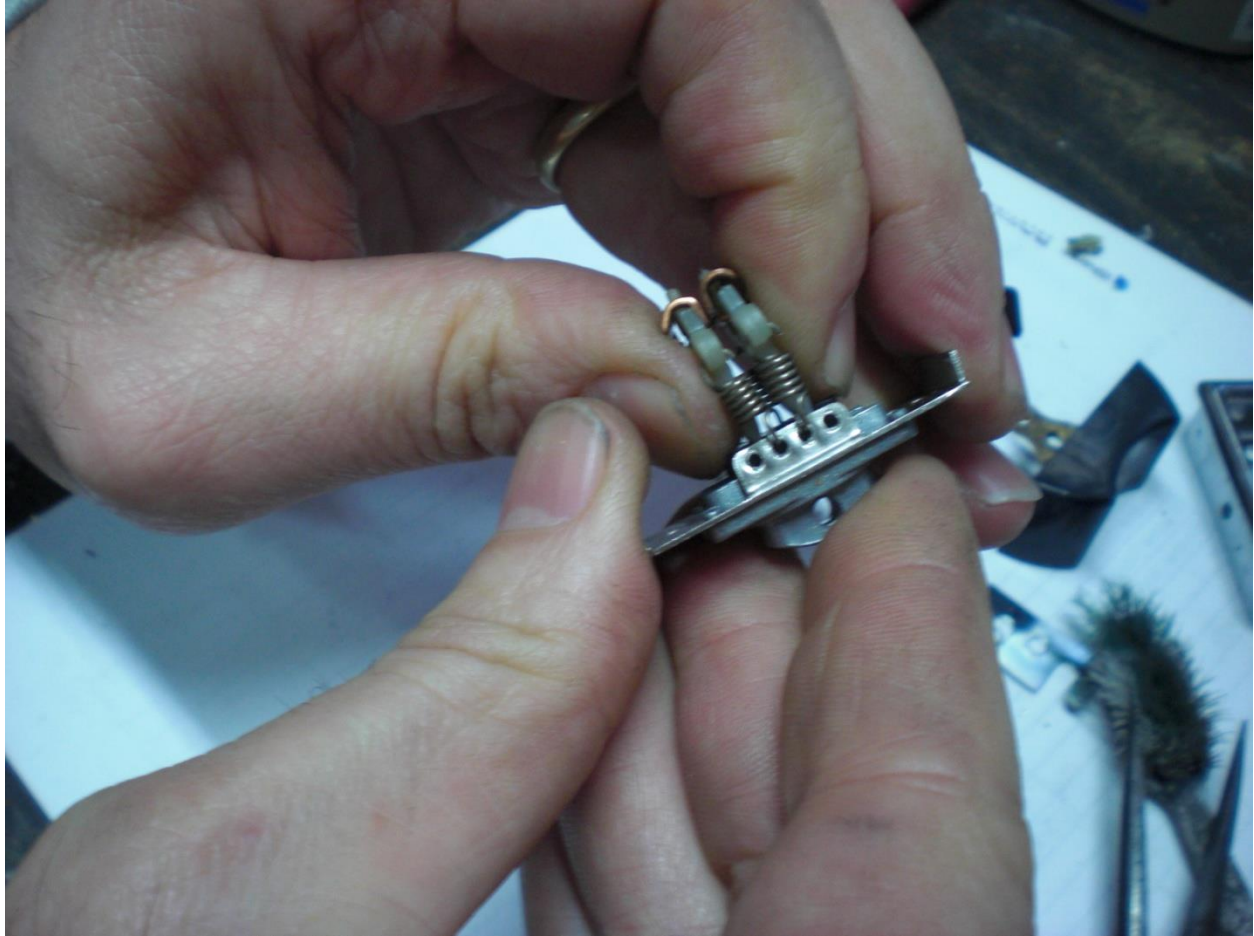
The result that you seek are the two spades attached to the base plate by four springs using the base plate's center most holes while the sharp end of the spades sit in the nylon slider's grooves.

Now, how you get there depends on your own dexterity. What works best for me is to first attach the springs to the spades (note orientation) and then attach the spade/spring combo to the base. After all four springs are attached; I lean the spades to one side and slip the nylon slider under them. Then I straighten the spades into the nylon slider's grooves. Be patient, it will eventually happen. Note that the nylon slider has two full width grooves on the spade side and two indents on the switch side. Although, I have seen nylon sliders with full width grooves on both sides. In this case, the narrower grooves go on the spade side.

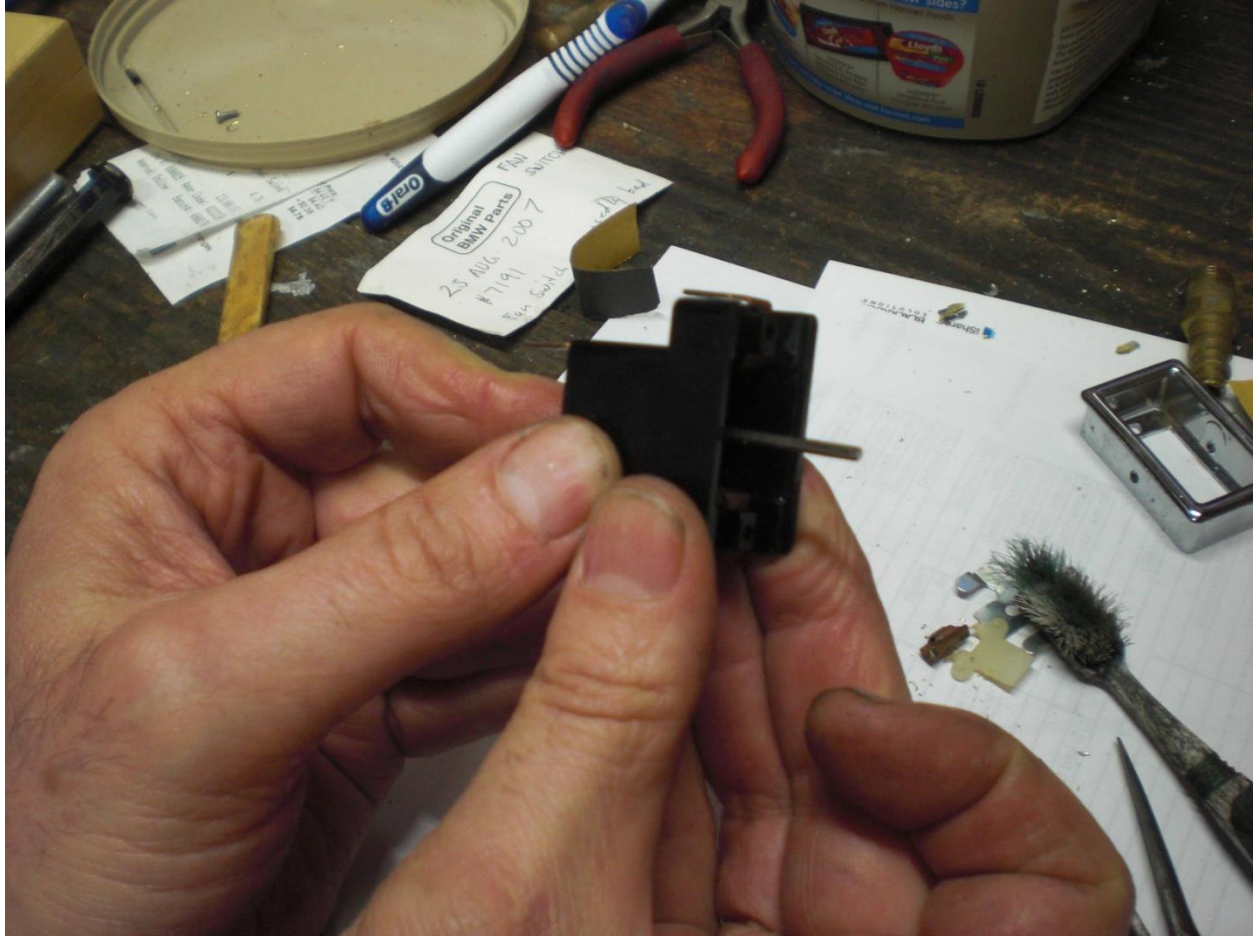
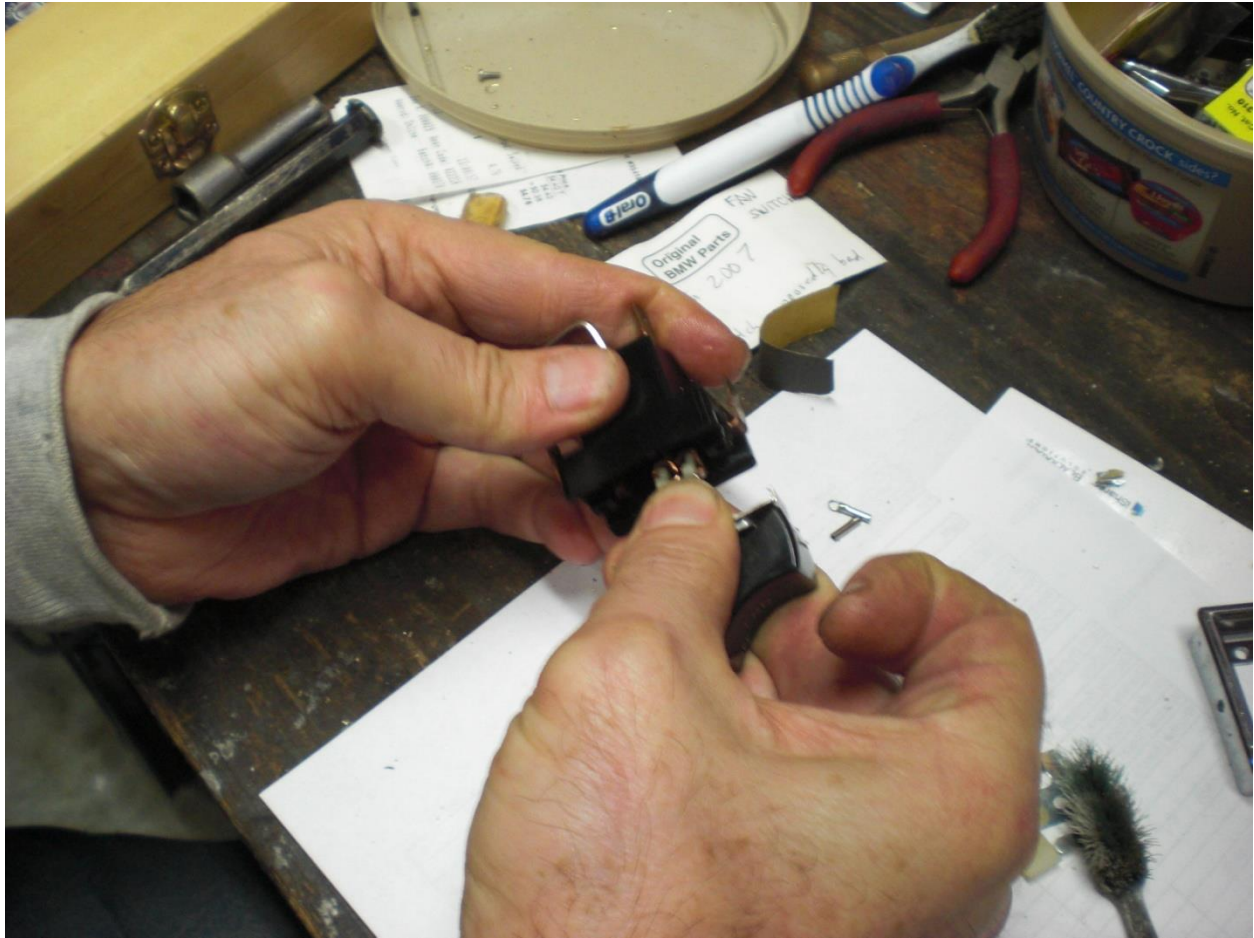
*As seen in this pic, I temporarily attach the button to help keep the nylon slider to which the spades are pressed from shifting side to side during the reinsertion.*

To get that subassembly into the case, I use a small allen wrench (the one I use for the 2-56 cap screws) inserted through the bottom of the case to help me keep the spades separated so as that they find their proper home, on each side of the tabs, when the subassembly is slid into the case. Of course, the allen wrench gets pushed out as you insert the spades and they find their home.

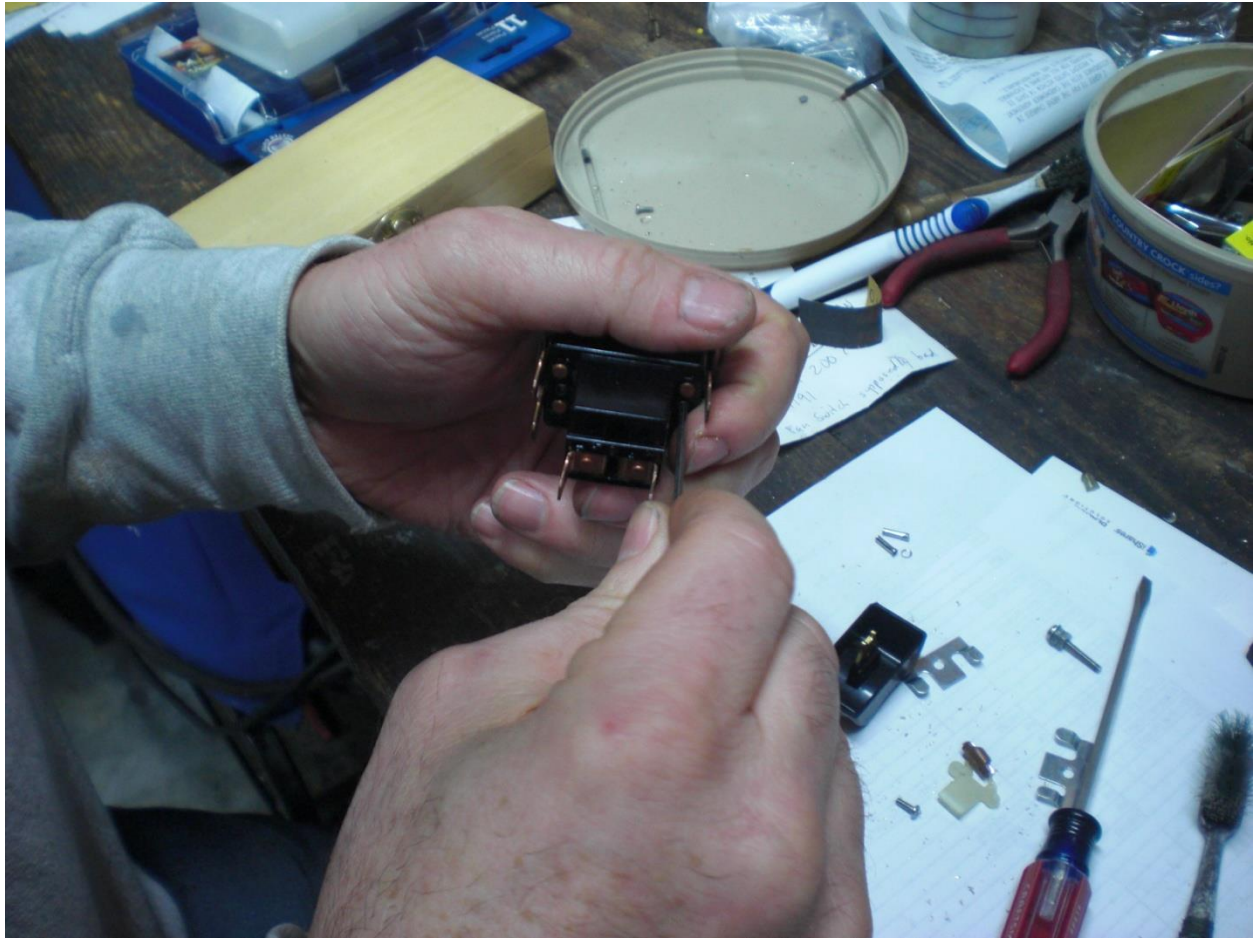
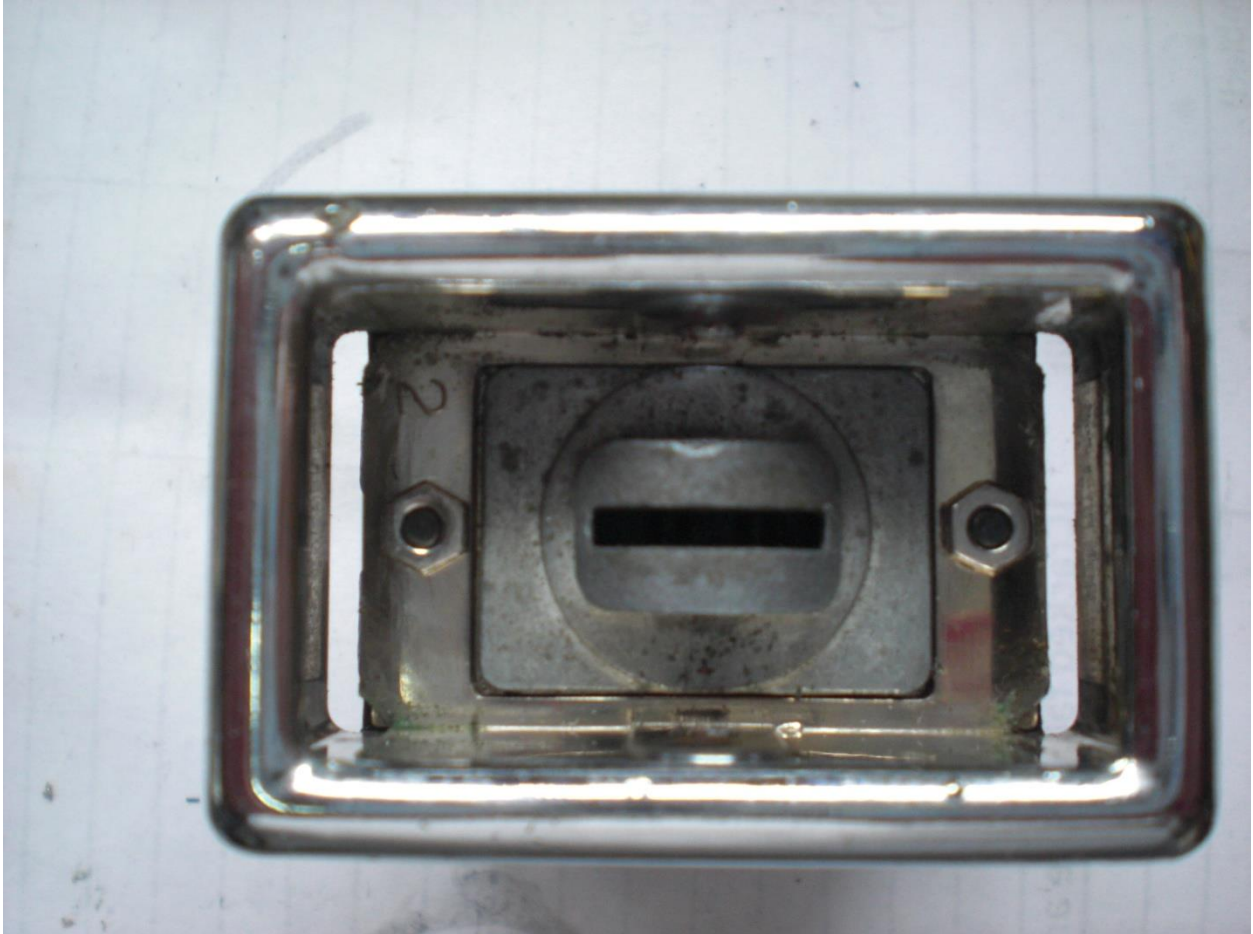
*Attached bezel with two nuts*

Holding the new bezel in place on the case assembly, install the two 2-56 1/2 long cap screws from the bottom thru the case and add the nuts on the bezel side to lock it in. Yes, it is a dexterity test with only two hands.

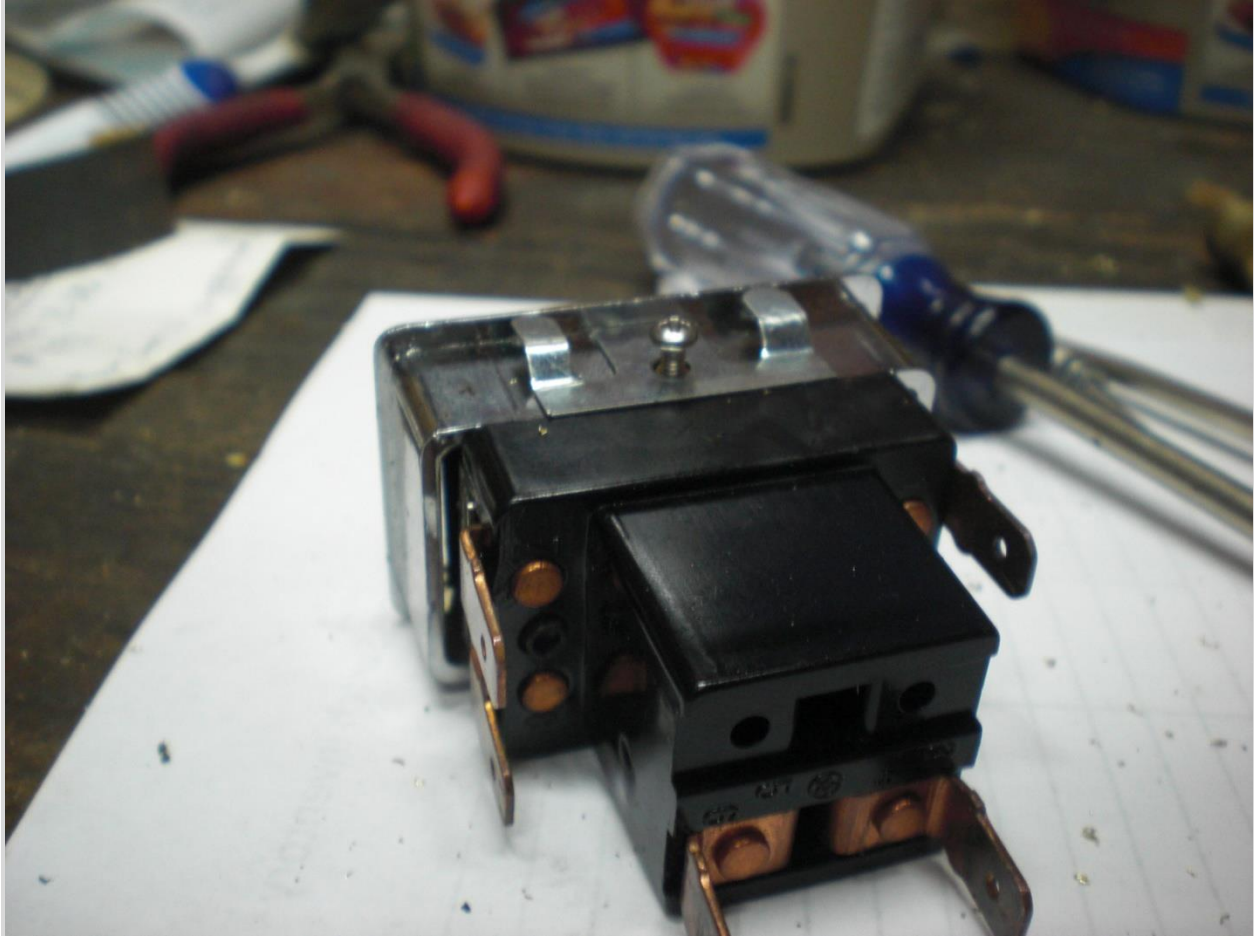
Don't forget the side prongs that hold the switch in place in the Console. Then use the short 2-56 machine screw to complete the rivet.

Reacquire the long rivet that you first removed and using your new 2-56 tap, thread the side from which you originally removed the flange. There is no need to drill the rivet to accommodate the tap.

Chamfer the end of the rivet that you just tapped to aid its insertion through the bezel and button.

When replacing the button, I find it helpful to first inspect thru the button's receiving slot in the guide plate to confirm that the indents on the nylon slider are centered. This ensures the button is properly engaged in its centered position when you place it back in the bezel to receive the rivet.
